Underground Updates

Presented by Quinn Malin

University of Alberta

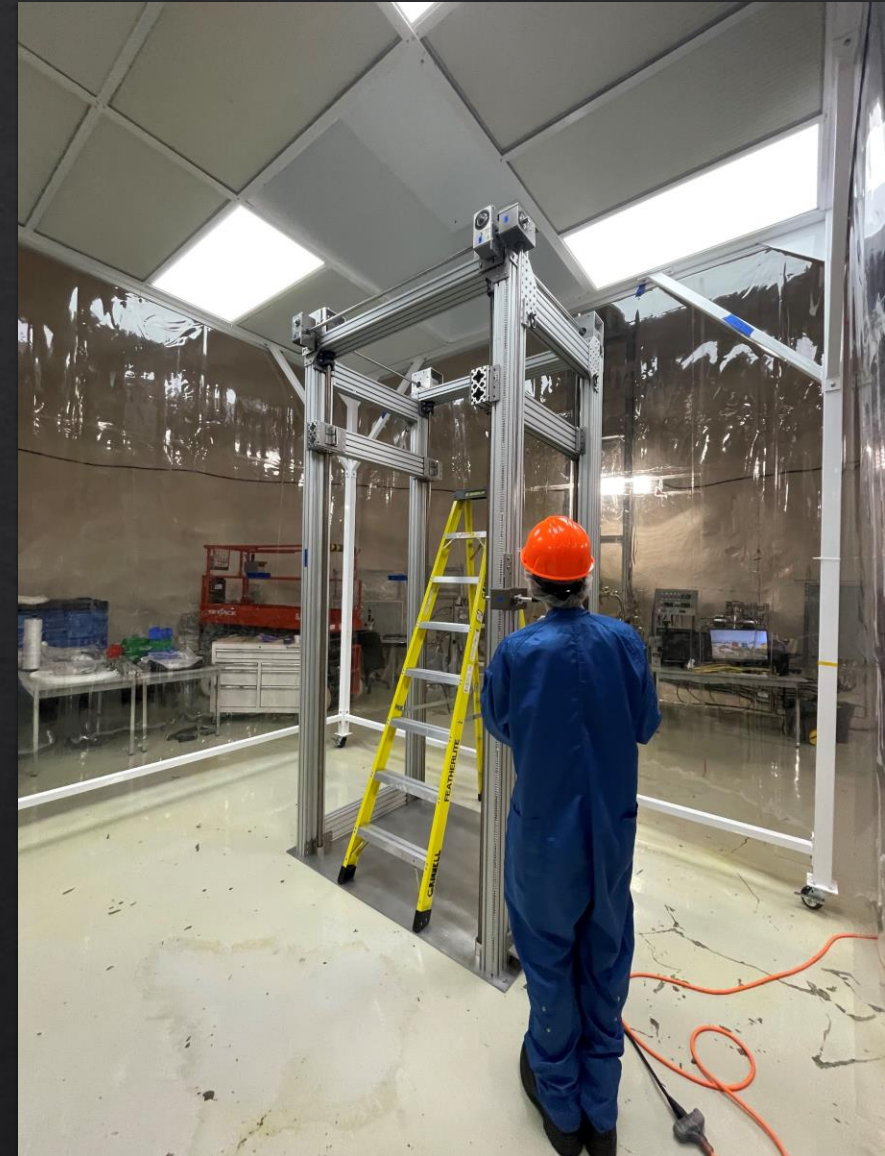
Assembly Table

- ◆ Installed underground
 - ◆ No problems in installation
 - ◆ No parts damaged

- ◆ Do we need to bolt this down to the floor?

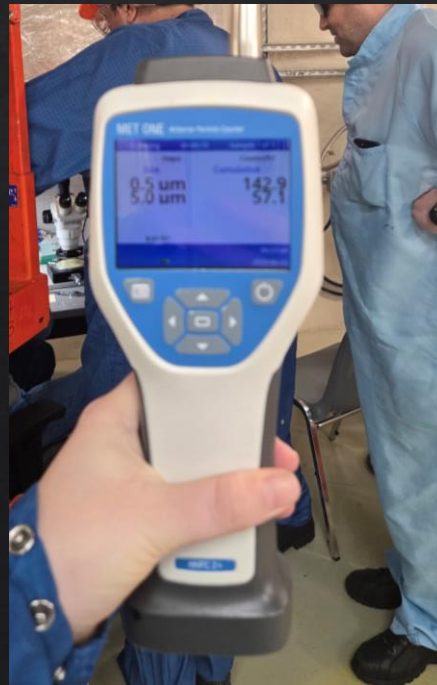
Particle Counts

- ◇ Fairly low in CR without movement
 - ◇ Multiple people working inside causes a lot more particulates
 - ◇ We need to produce a full procedure for cleaning before we enter the cleanroom (Ashley)

- ◇ Particulate counts in BAD (back access drift) are very BAD
 - ◇ Well over 1000 counts/ft³ for 0.5um and 5um
 - ◇ Largely due to holes in the door between lab and drift
 - ◇ Recently patched, but should be considered when transporting parts through the area
 - ◇ Mitigated with Radon bag?

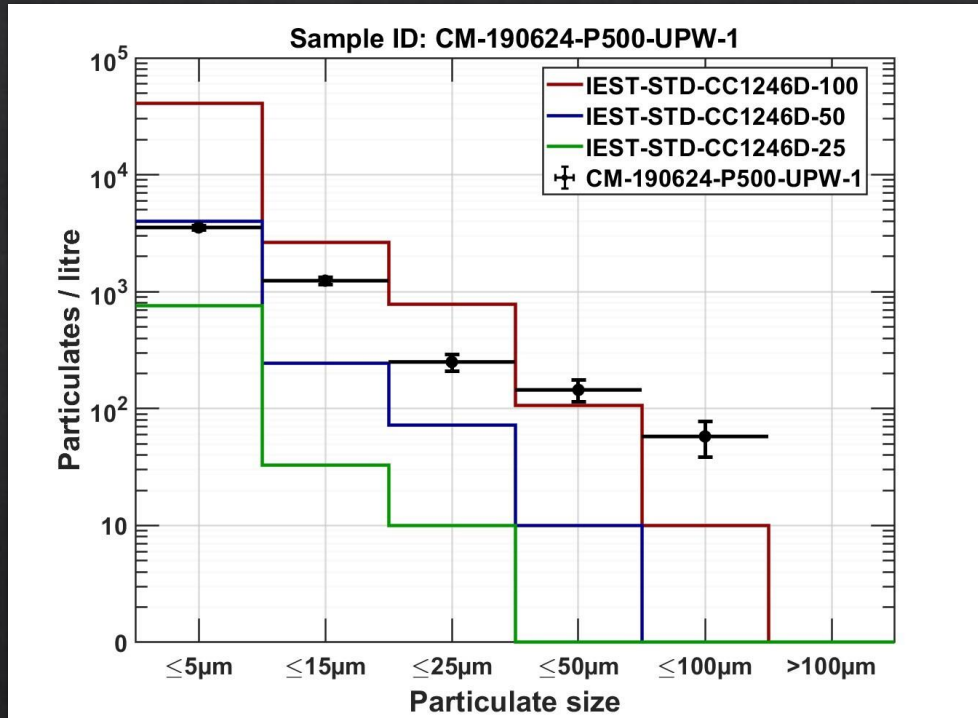
Mini clean UPW

UPW line samples

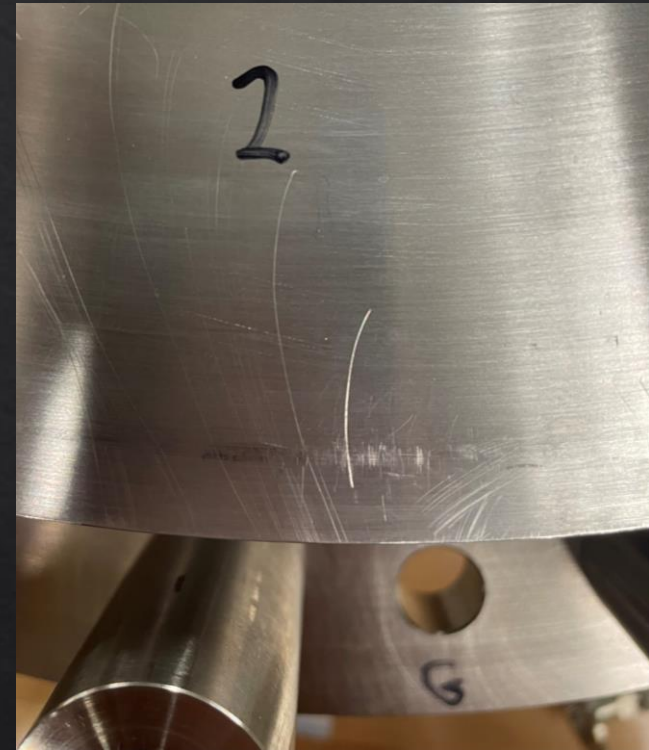
Testings Underground

- ◇ After PICO He leak checker was fixed, we performed leak tests on the bellows and surrounding parts
- ◇ Known leak on the IV assembly
 - ◇ ****Part is not going in final assembly****

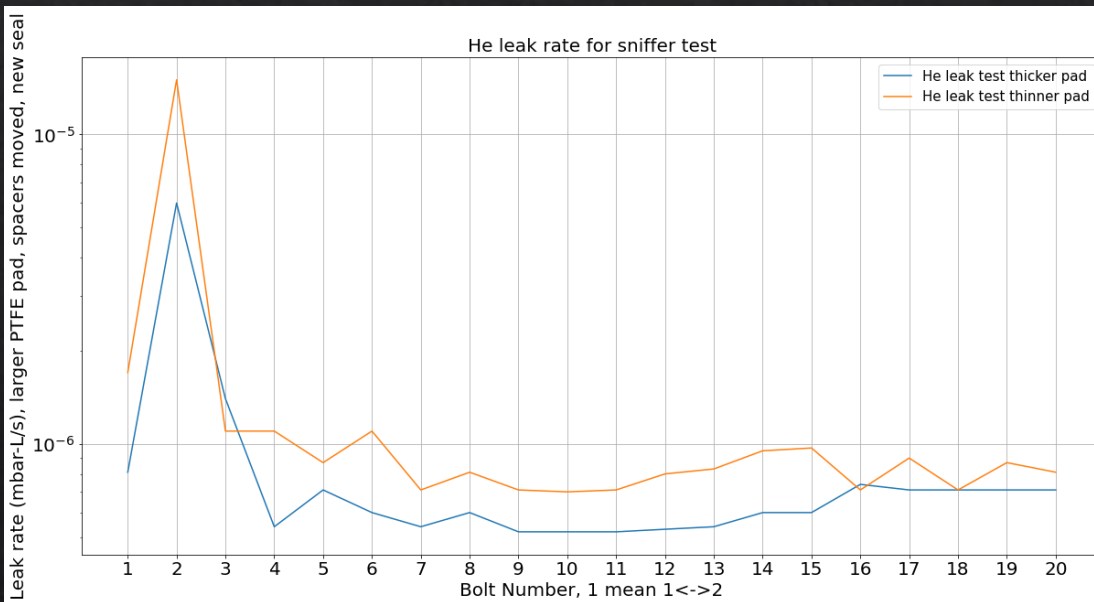
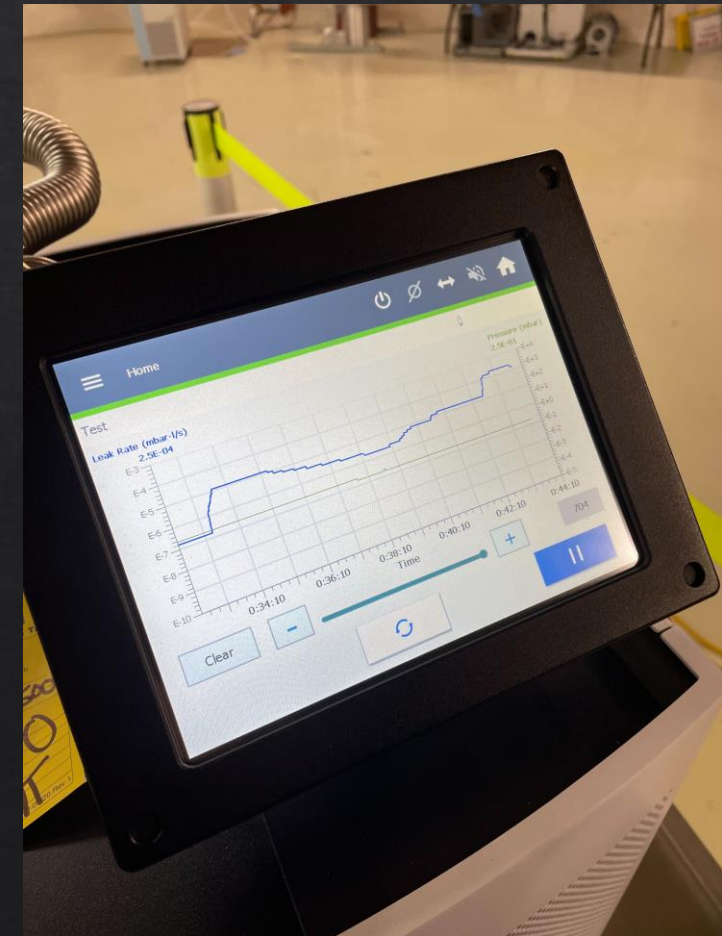
Leaks

- ◇ Sniffing test is far less accurate
- ◇ One major leak located (possibly in same position as the one before but needs to be confirmed)
- ◇ Leak checked all of bellows, only leak near the A1 flange (with know leak)
- ◇ Reached roughly $2.5 \cdot 10^{-4}$ mbar 1/s
