# Bellows Contingency Plan

Risk Assessment

Presented by Quinn Malin

University of Alberta

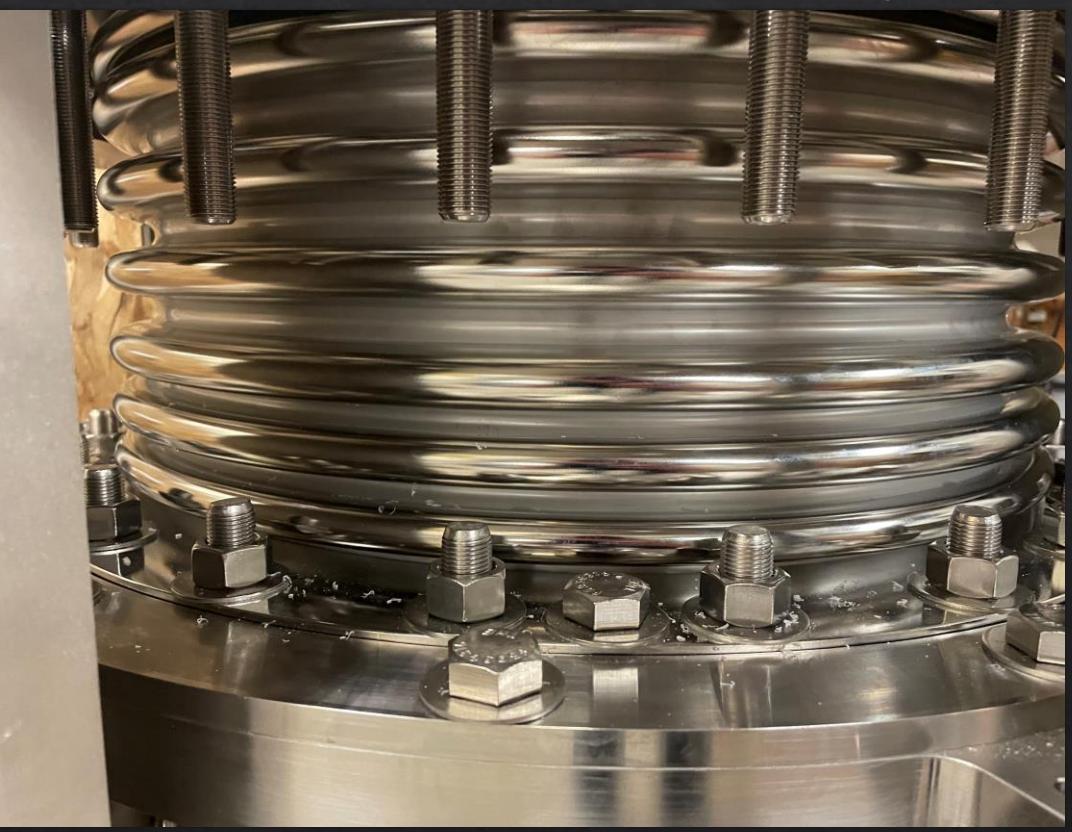
- ♦ After filling to 4 psi. closed valve and disconnected parts (rated +/- 20 psi)
- ♦ Bellows status here
  - ♦ Plastic deformation
  - ♦ Spring constant probably changed
- Did some rough estimating with CAD
  Roughly 3" +/- 0.5 extension on bellows
  Our limit is 2.5"?

Caveat: this is after a little bit of work done towards fixing the bellows

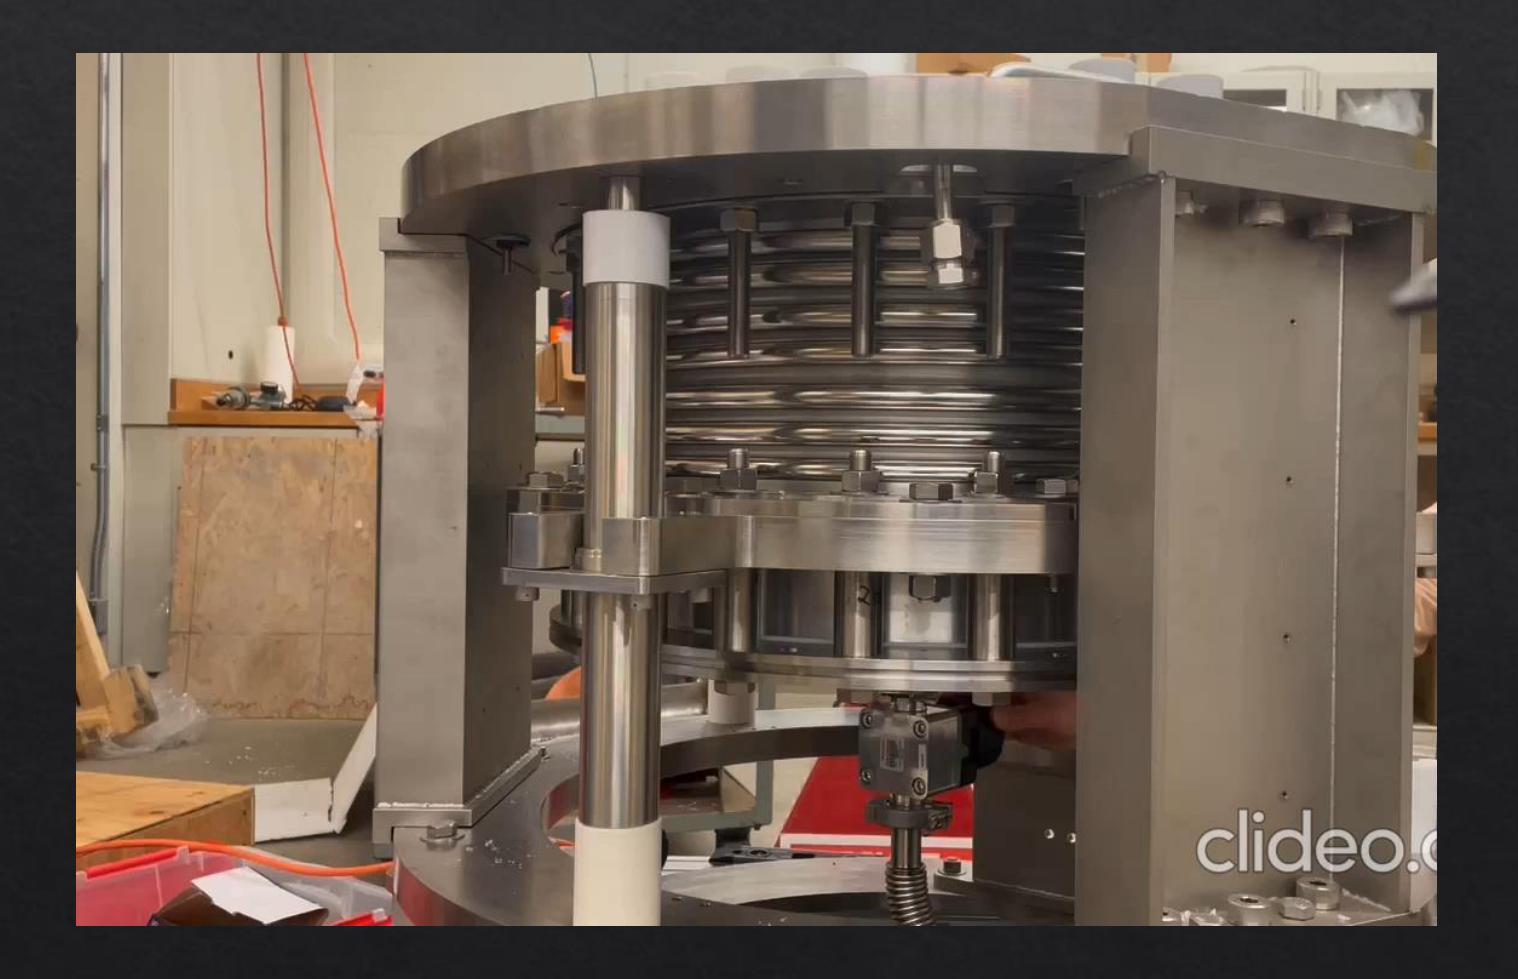
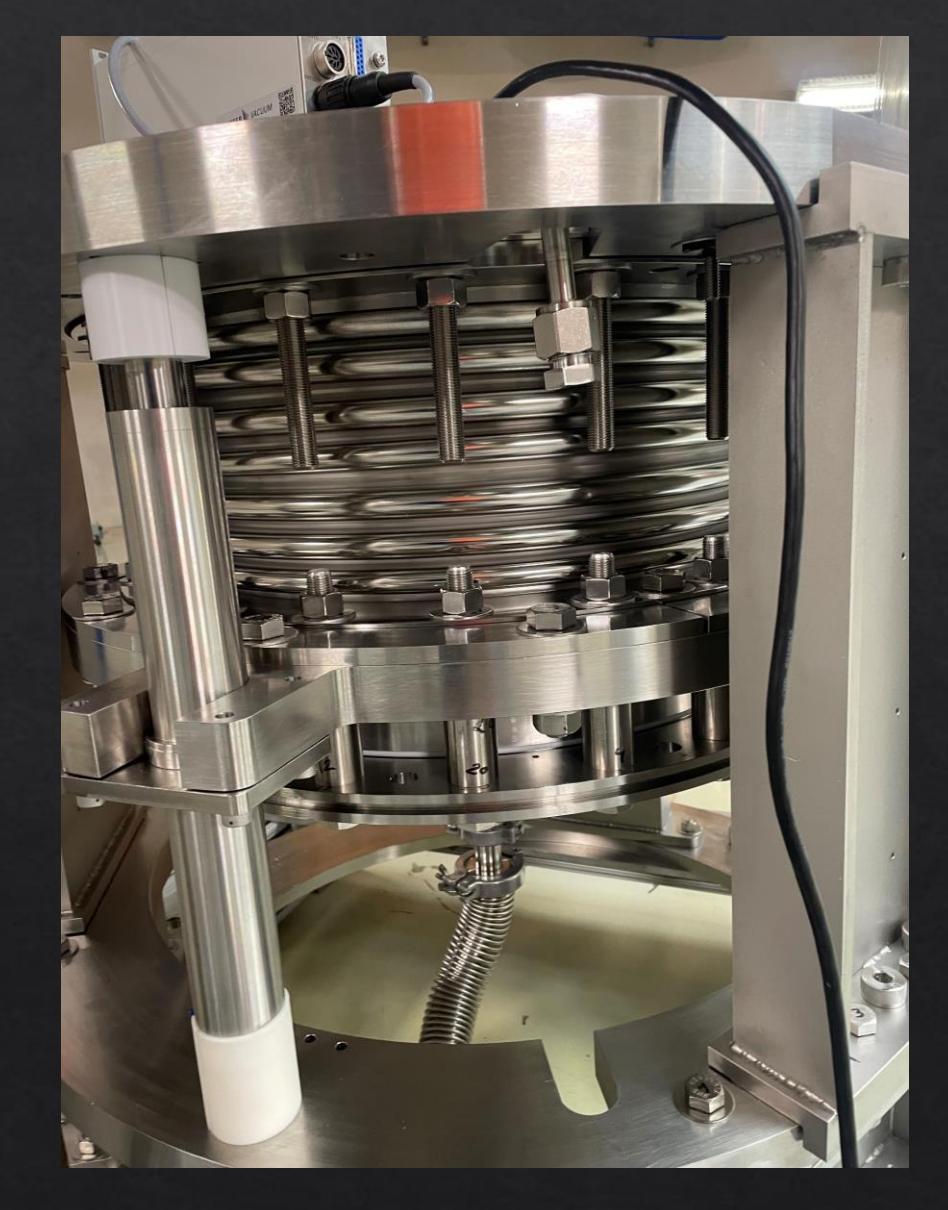
# Current State

- $\Leftrightarrow$  +/- 0.78", 1.5mil cycles to failure
- $\Leftrightarrow$  +/- 2.5", 2900 cycles to failure
- $\Leftrightarrow$  +/- 4.7", 239 cycles to failure
- ♦ These are strictly statistical, so the 4.7" deflection could be taken with a grain of salt....
- ♦ With my rough calculations for deflection, why did we see a large deformation....

- ♦ Will this effect bellows events?
  - ♦ Particulates do "flake" off, but this will be removed in cleaning.
- The PICO-401 bellows were damaged, but they still work fine.
  - ♦ How were these bellows damaged?

- How many cycles can we still achieve with a normal deflection of 0.75" (expected travel distance of compression/expansion)
  - Realistically, the deformation probably reduced this by 50%

- Decide as to whether we purchase a new bellows
  - And will use these bellows in the construction
- ♦ In favor of using current bellows

- We can reshape the bellows, as done before at UofA
  - ♦ But will this cause more damage?
- Solution States Stat
